REPORT OF
PHASE II INVESTIGATION
FORMER ABEX FOUNDRY
6600 RIDGE AVENUE/6538 HOBART AVENUE
WELLSTON, MISSOURI

St. Louis County Economic Council
121 North Meramec
Suite 900
St. Louis, Missouri 63105

Project #0140

February 7, 2002

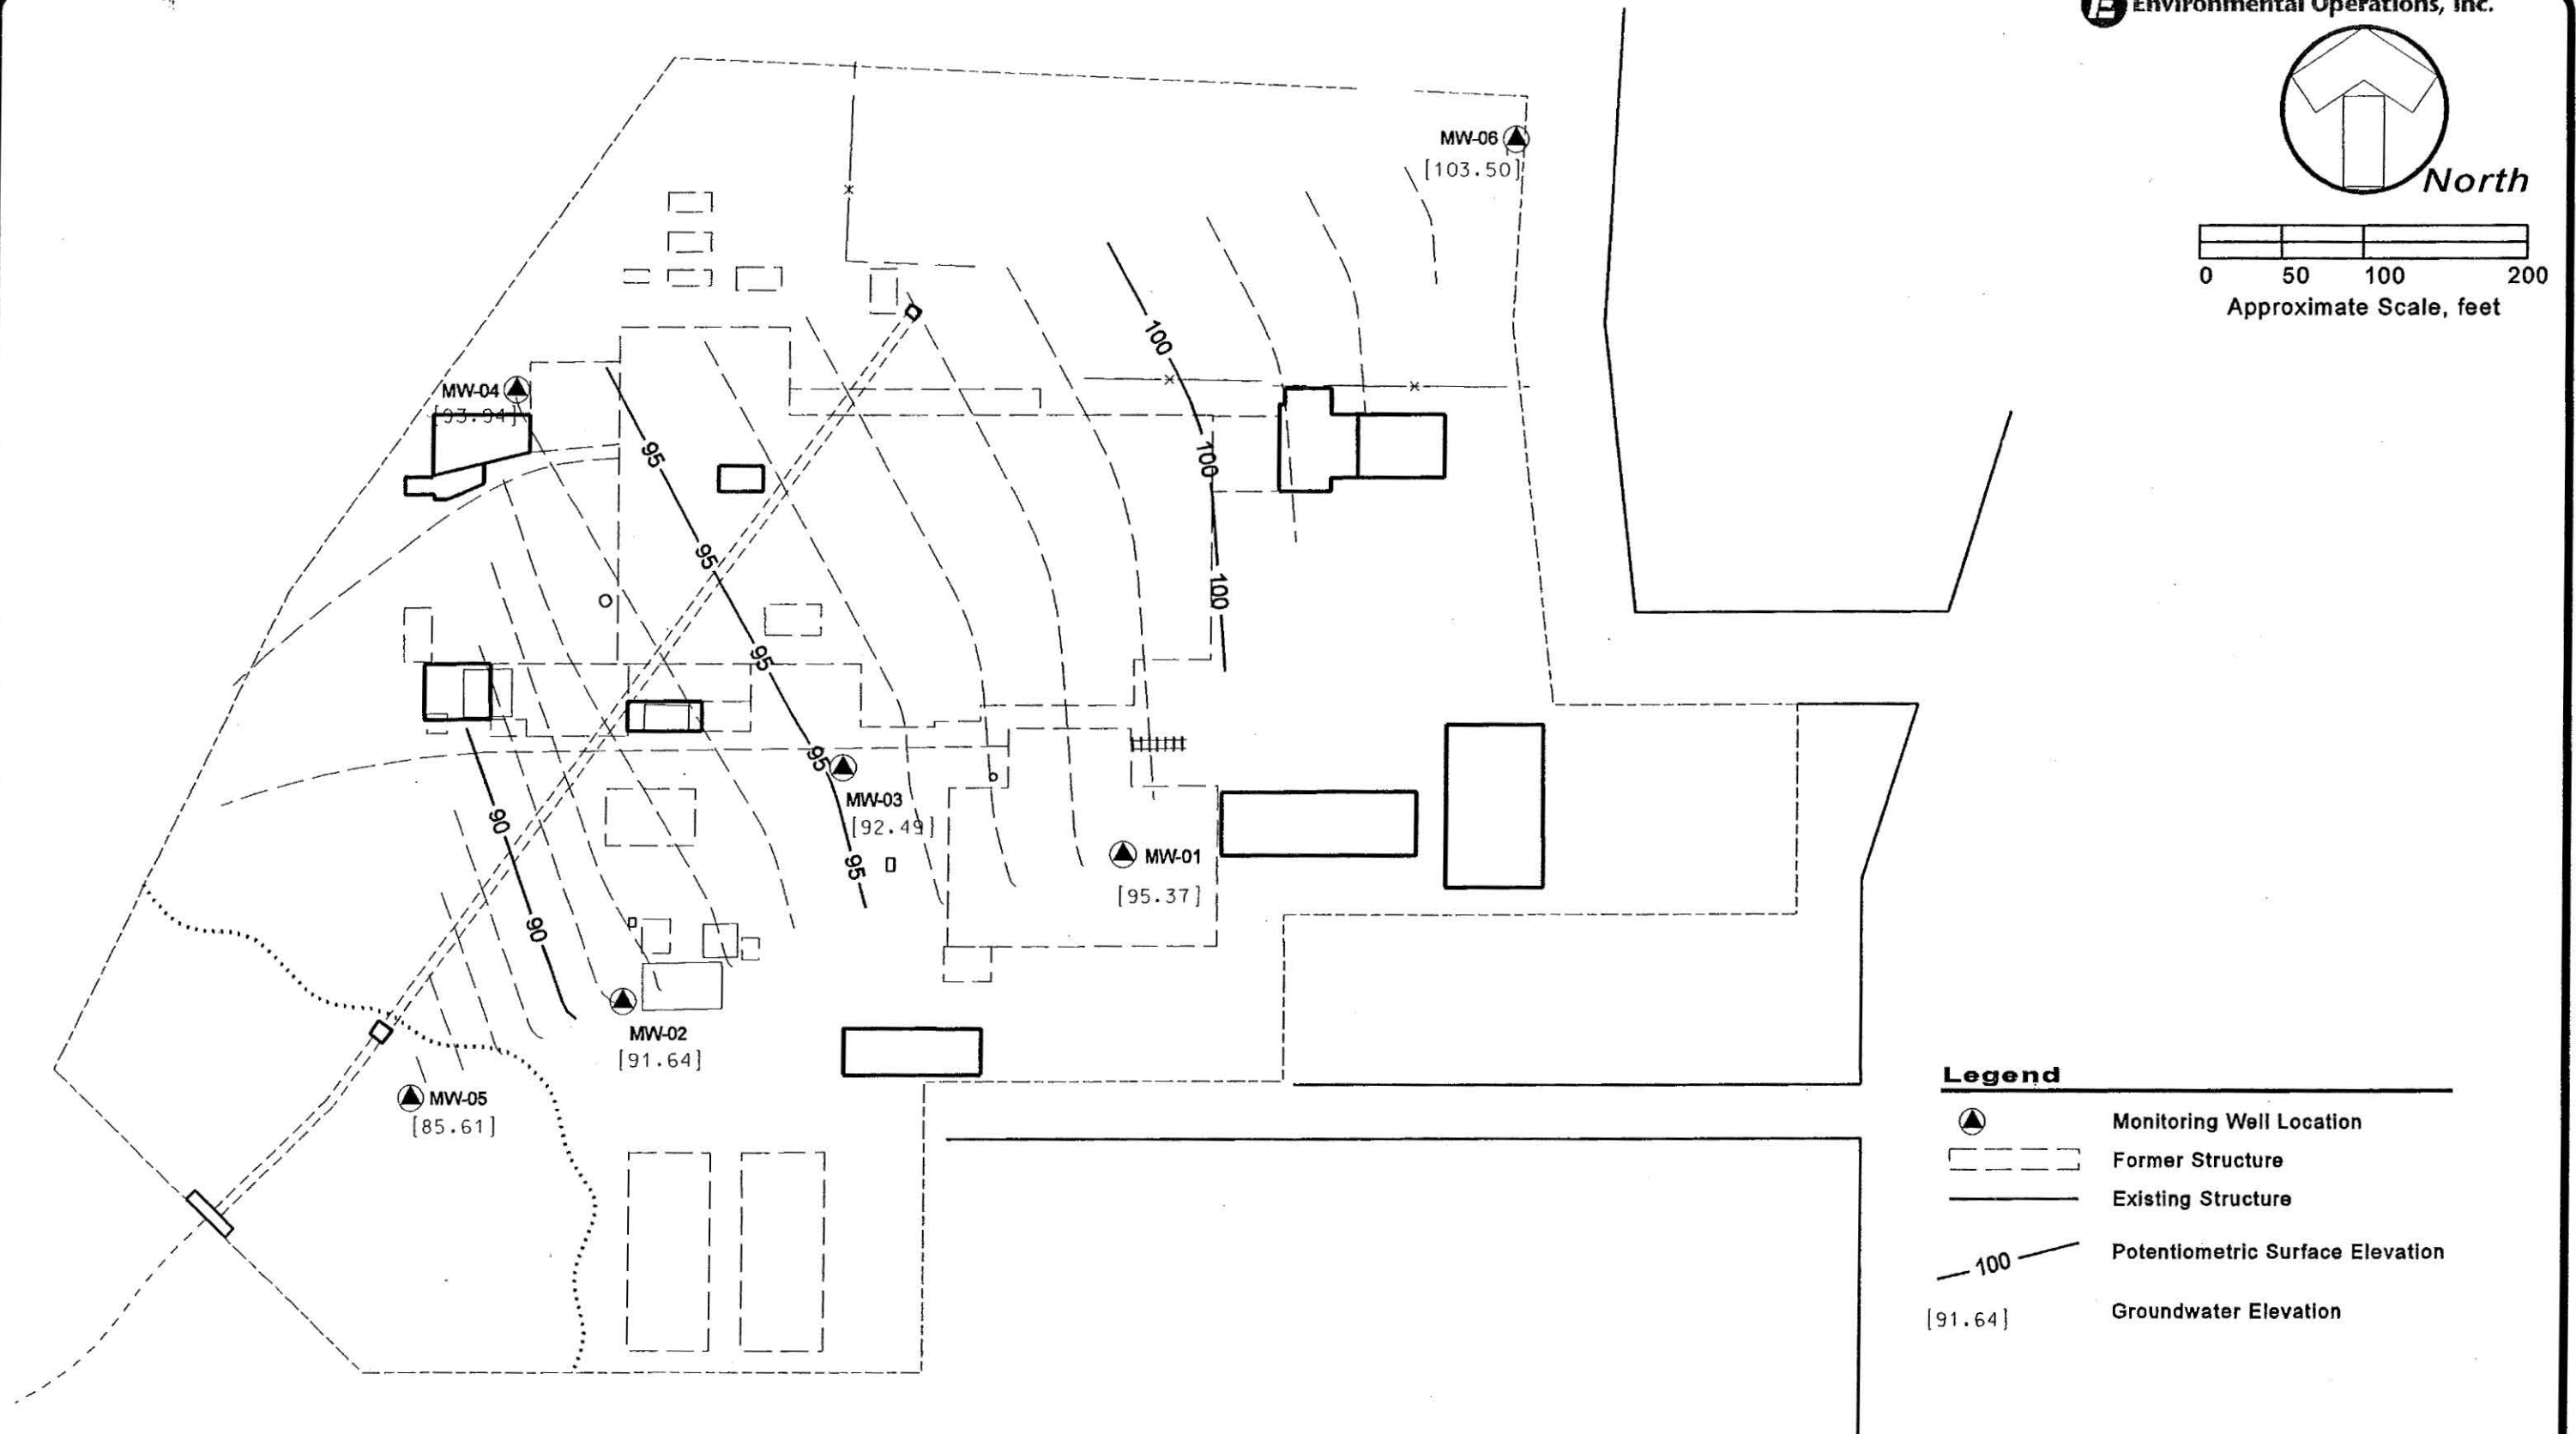
Potentiometric Map, 18 December 2001
Former Abex Foundry
Wellston, Missouri

On December 18, 2001, prior to purging the wells, static groundwater elevations were collected in order to determine the groundwater flow direction. Based on measured groundwater elevations of the six monitoring wells, a groundwater elevation contour map was prepared. This map indicates that groundwater flows in a southwesterly direction.

Figure 4 located in Appendix A depicts the calculated groundwater flow in the area of the subject site.
